Comments on Draft Report Dynegy Midwest Generation- Vermilion Power Station

**RE: Draft Coal Combustion Waste Impoundment Round 6 - Dam Assessment  
Report Dynegy Midwest Generation, Inc. Vermilion Power Station Fly Ash  
Dikes (Site 015), dated September 2009**

**DMG Comments**

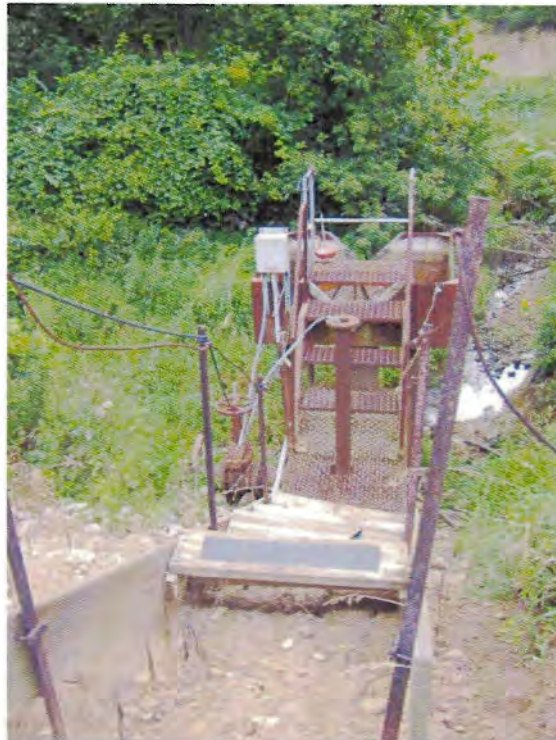
Figure 5.4.1-1: Photograph of the North Ash Pond System Overflow Structure.

The North Ash Pond System overflow structure was observed to be working properly, discharging flow from the pond, and visually appeared to be in satisfactory condition. There was no sign of clogging of the spillway and the water exiting the outlet was flowing clear. Figure 5.4.1-1 shows the main outlet structure.

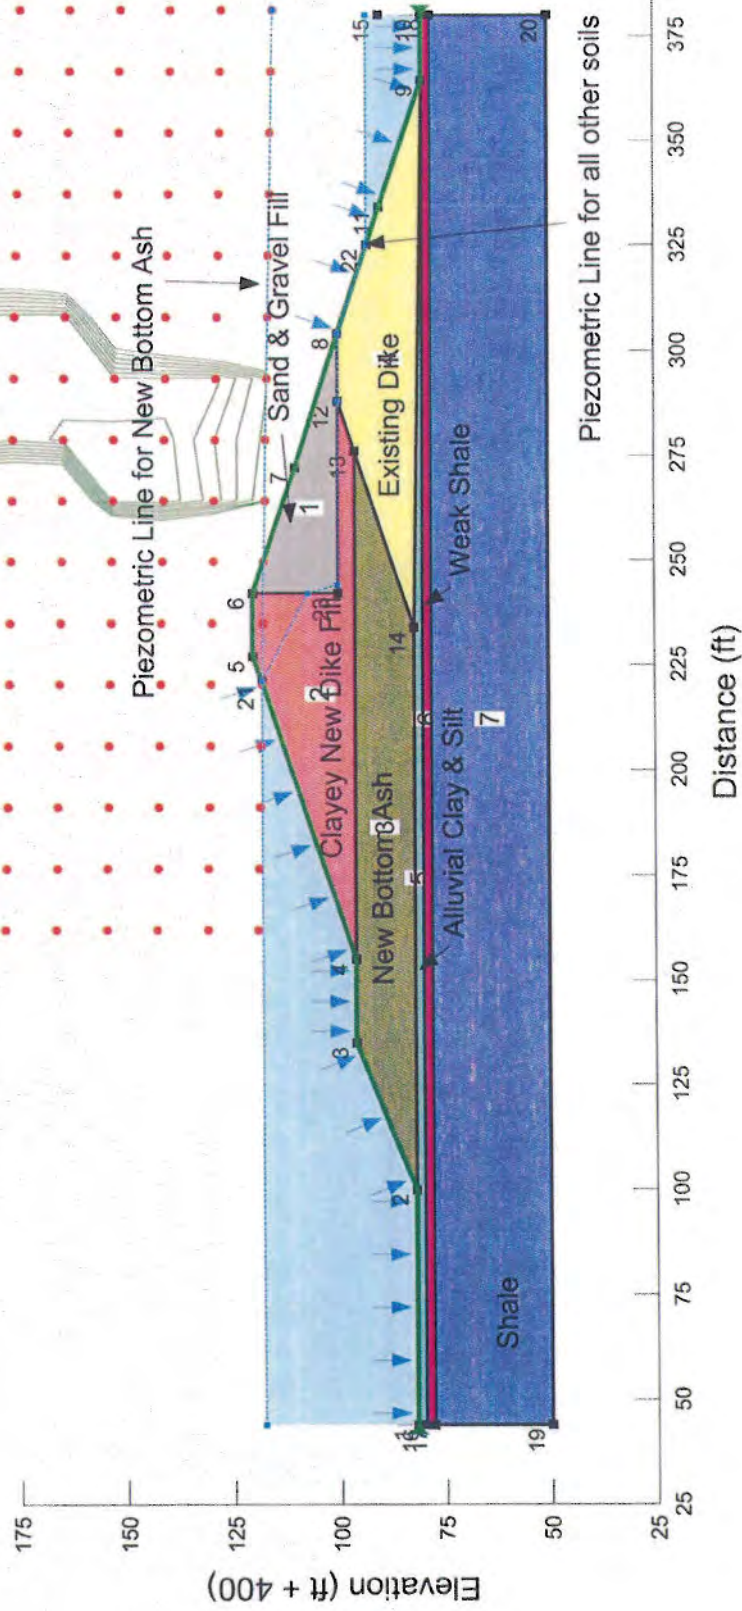
Case	Original (Drained Soil Properties) Factor of Safety	Revised (Undrained Soil Properties) Factor of Safety
2A: Downstream Slope, Full Pond, Seismic and Gravity Loads	1.4	2.0
2B: Upstream Slope, Full Pond, Seismic and Gravity Loads	1.2	1.2
3: Upstream Slope, 20 ft rapid drawdown, Gravity Loads Only	1.3	1.4

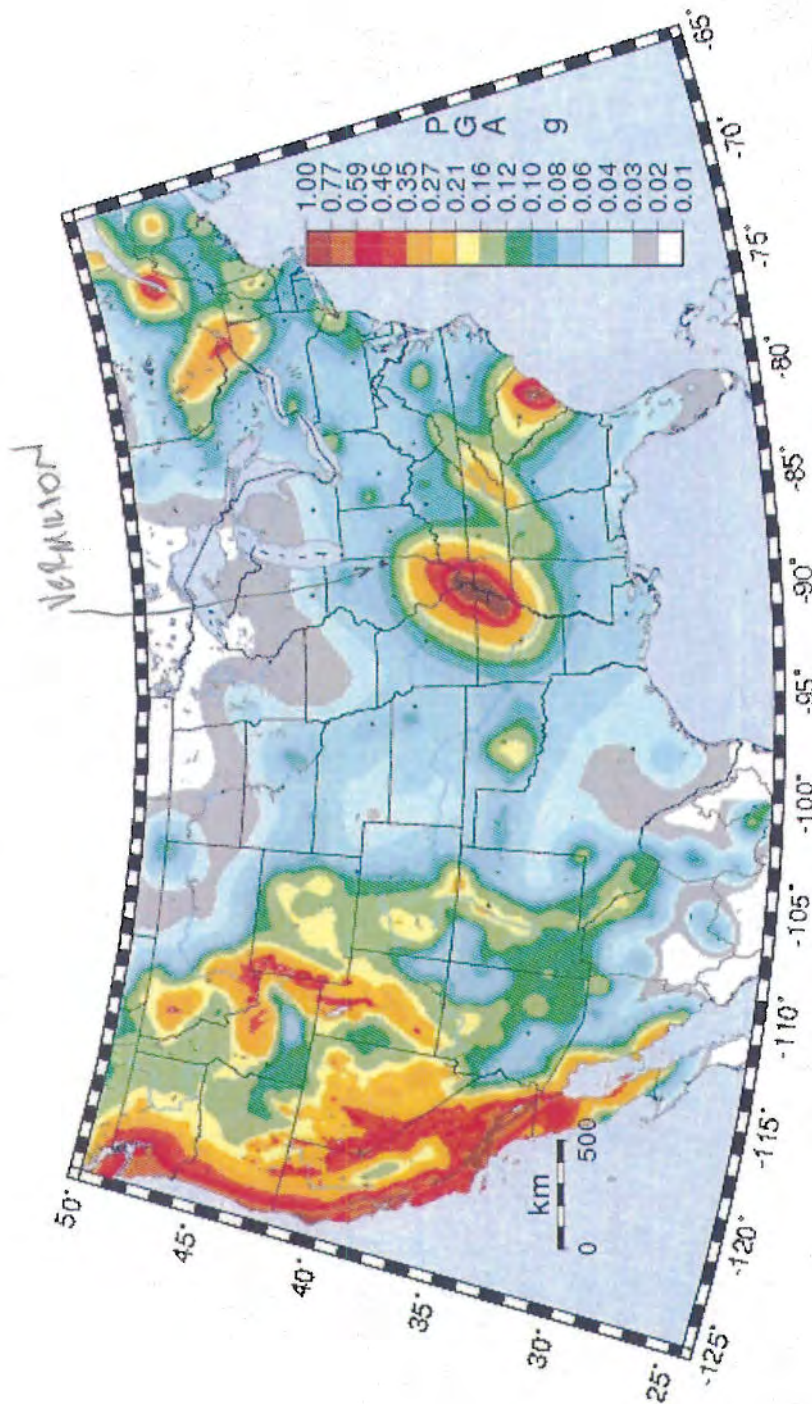
PGA with 2% in 50 year PE. BC rock. 2008 USGS

According to the current USGS website, the peak ground acceleration (PGA) with a 2% probability of exceedance within 50 years is between 0.08 and 0.10 g for this site (refer to the enclosure). It is generally understood in the geotechnical community that sites with a PGA with a 2% probability of exceedance within 50 years of less than 0.10 g are not considered to be within a seismic impact zone.
